DOT/FAA/PM-83/31

# Rubber Removal from Porous Friction Course

Department of Civil Engineering  
University of Illinois  
Urbana, Illinois 61801

Final Report

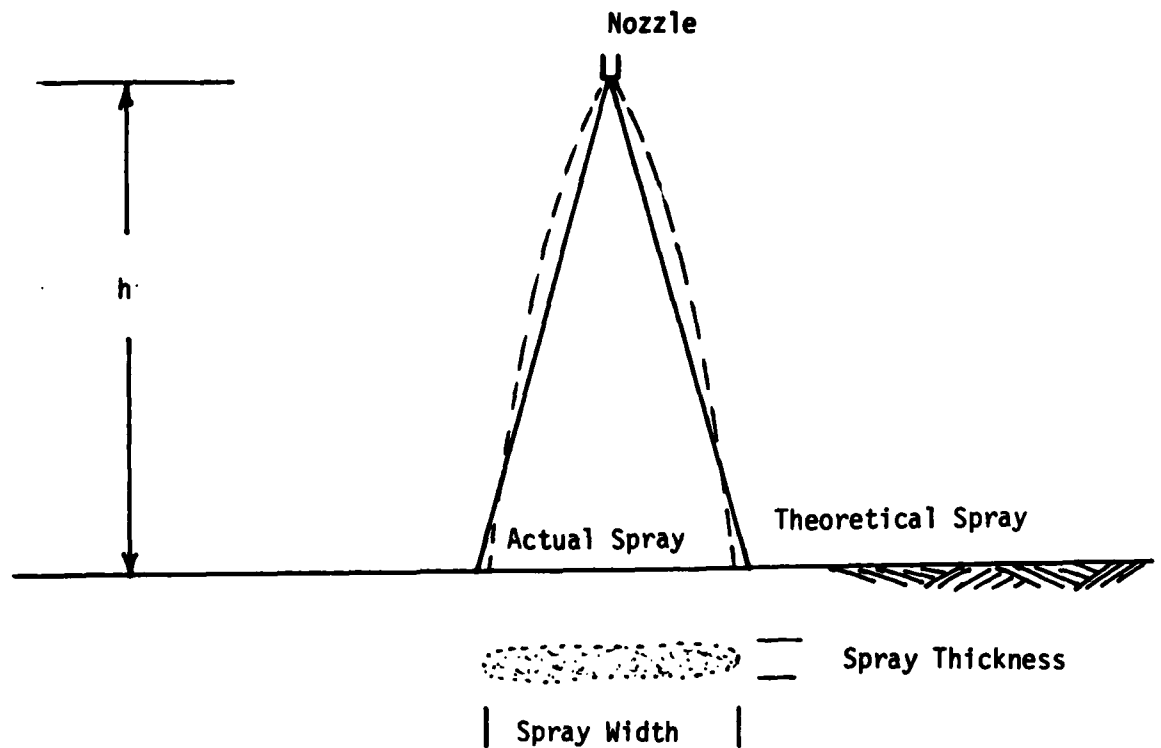
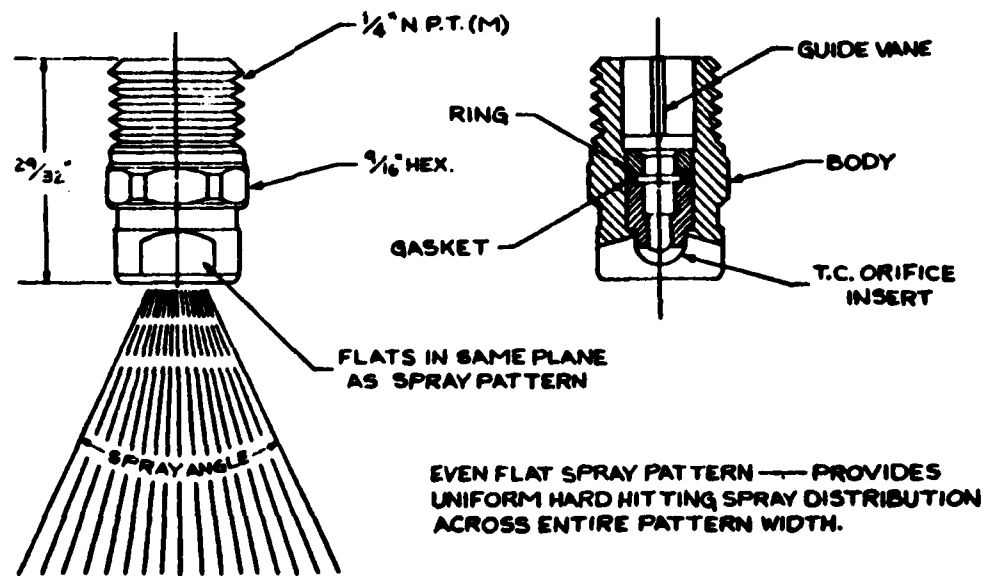
Figure B-1. Spray Nozzle and Spray Fan Configuration, from Spraying Systems Co.

A spray nozzle and the water spray fan are shown in Figure B-1. The idealized spray fan is shown with the actual coverage superimposed. The actual coverage is greater than the theoretical coverage only for small distances above the pavement surface. Figure B-2 illustrates the difference for a nozzle commonly used in rubber removal. The spray fan is much wider than the theoretical prediction for the small heights commonly used in rubber removal projects. The thickness of the spray fan increases with height also. This increase is shown in Figure B-3 for the typical nozzle. With the change in the width and thickness as the height of the spray fan increases, the force per unit area decreases, which decreases the work being done. The cross sectional area can be calculated as follows:

$$\text{Area} = A = a + 2 \left( \frac{h}{\tan \frac{\alpha}{2}} \right) (0.0192h + 0.0947)$$

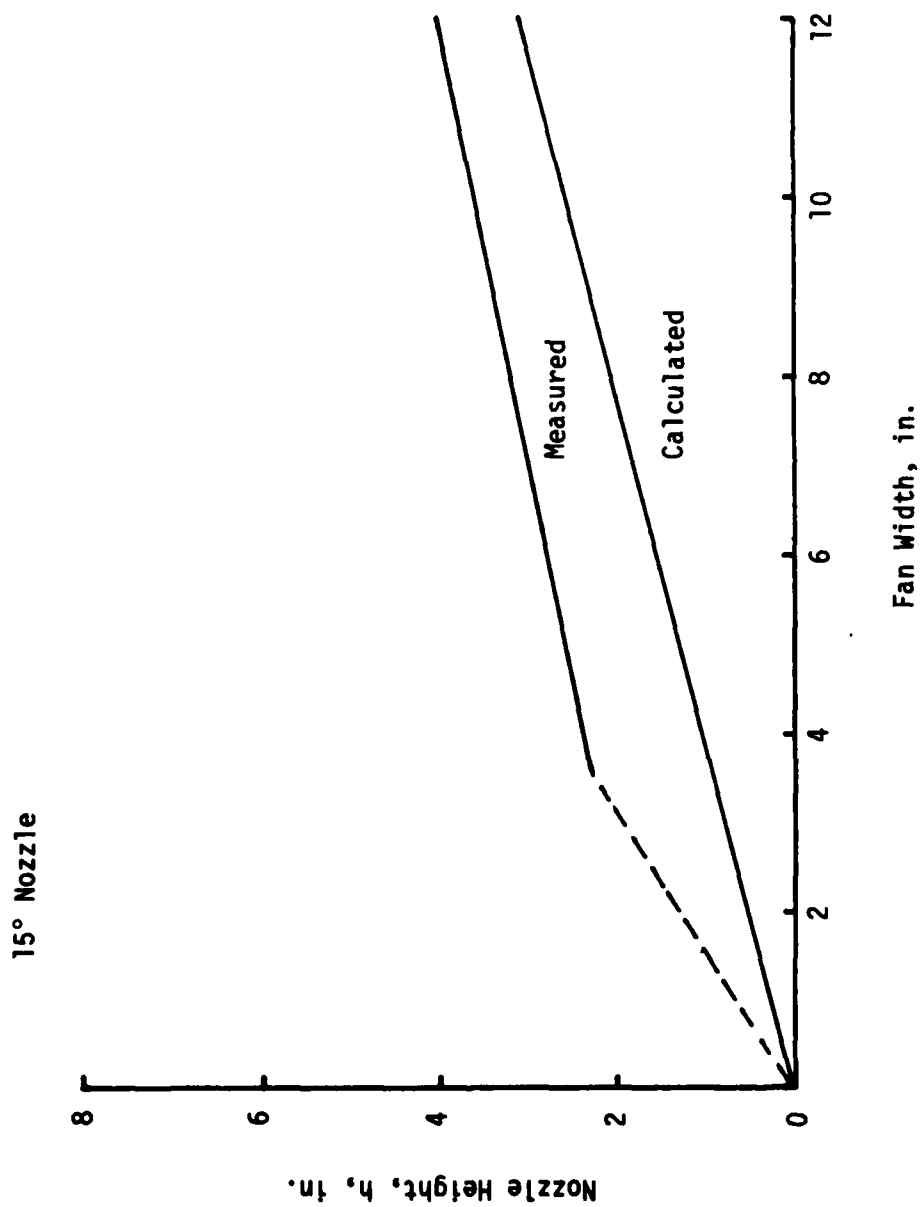
Figure B-2. Variation in Fan Width as a Function of Spray Bar Height, Comparing Actual to Theoretical.

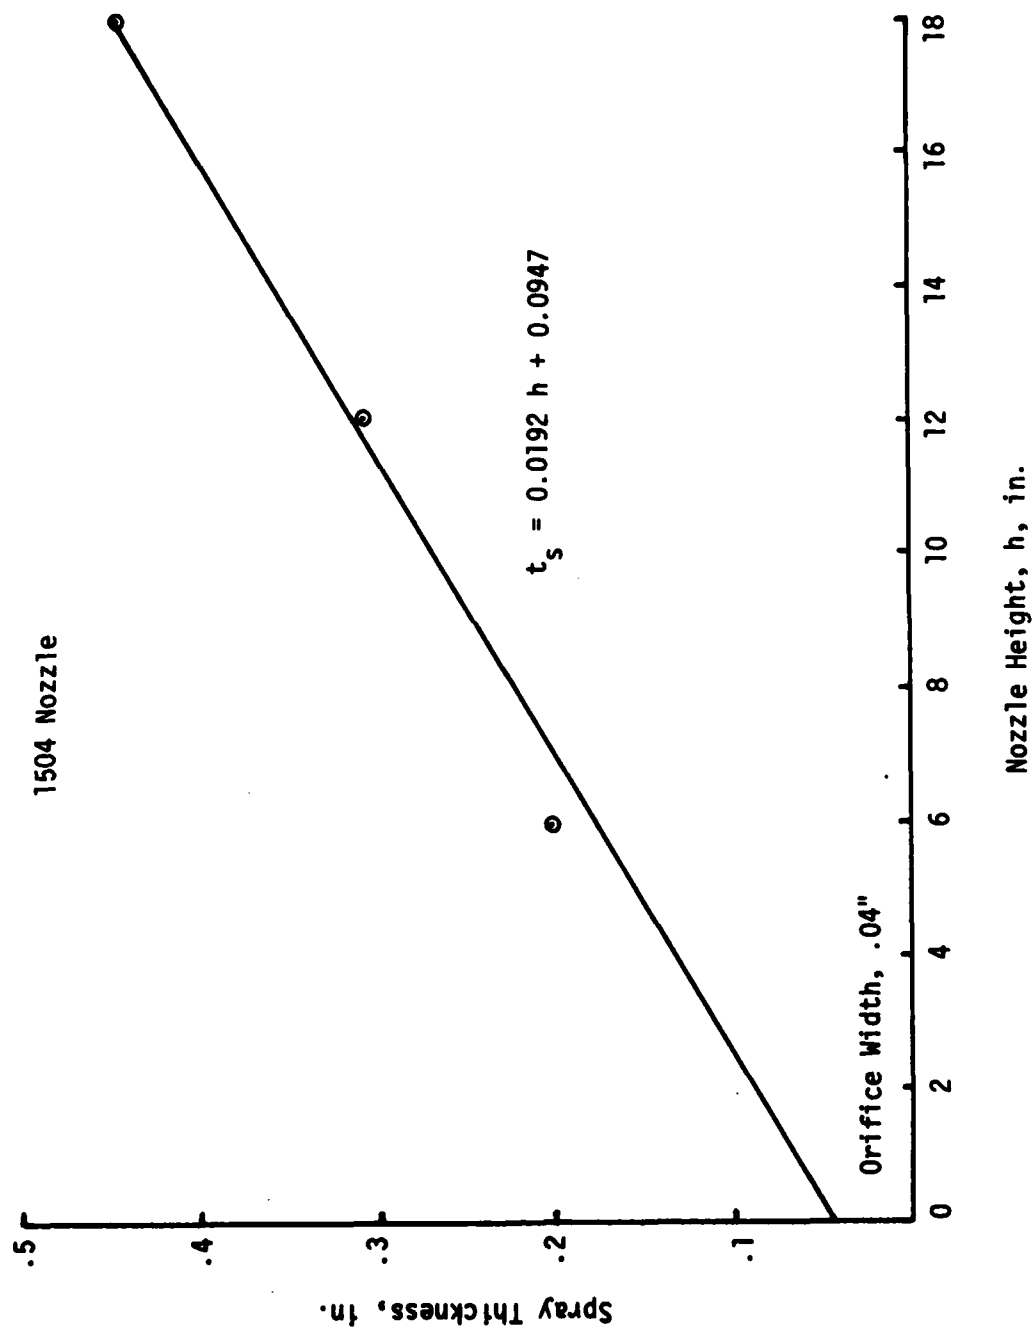
Figure B-3. Variation in Fan Spray Thickness as a Function of Spray Bar Height.

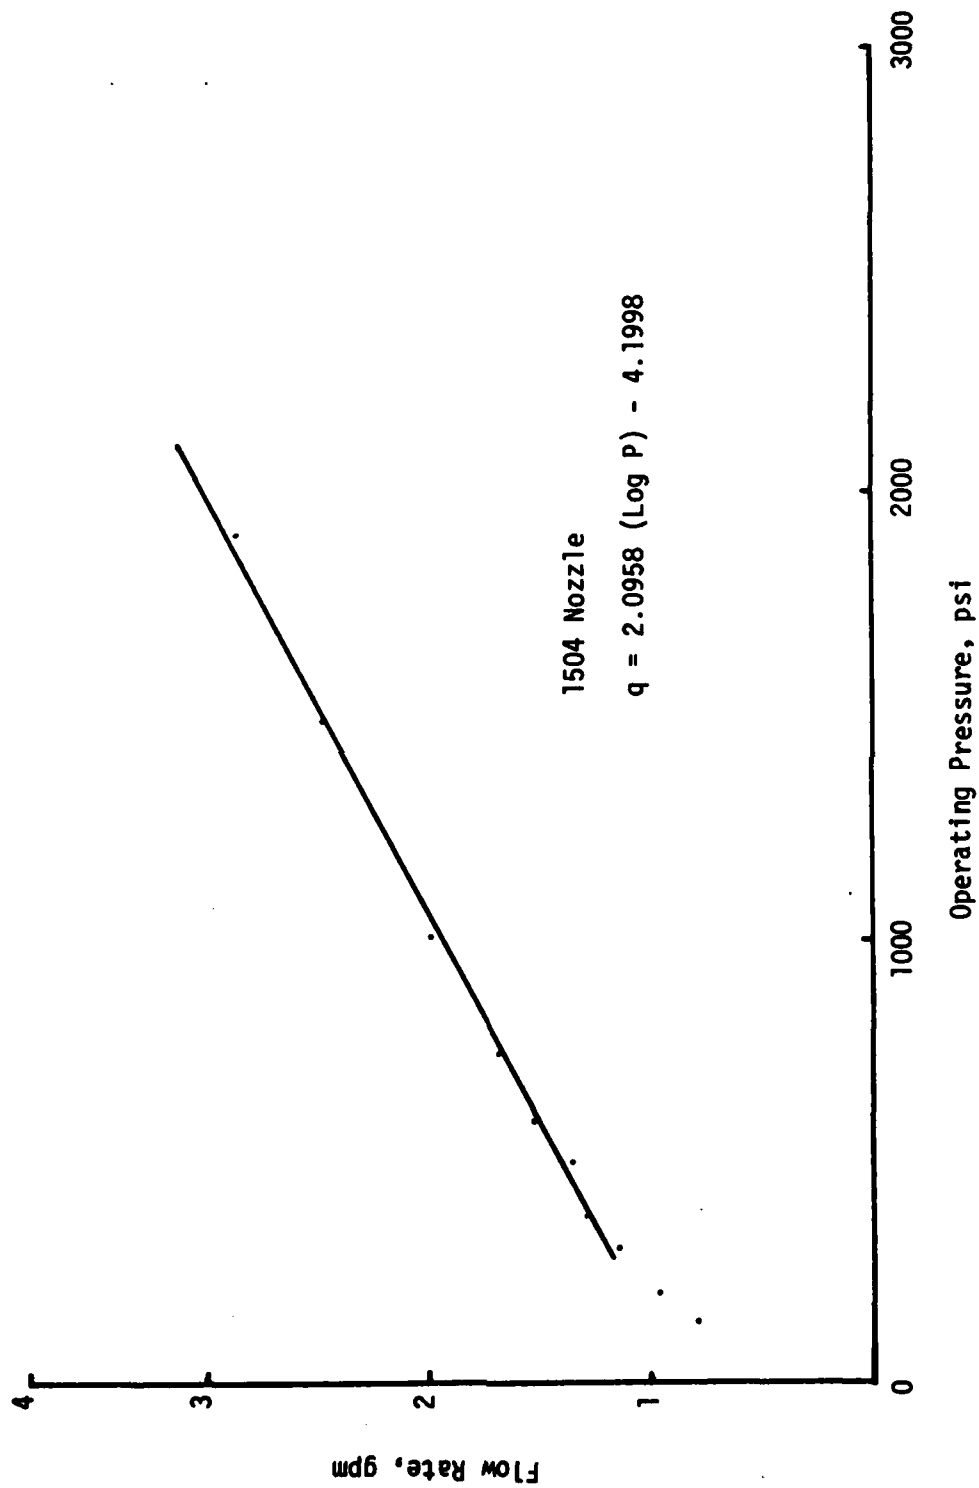
Figure B-4. Flow-Pressure Relationships for Nozzle Type 1504. Indicating Typical Operating Characteristics.

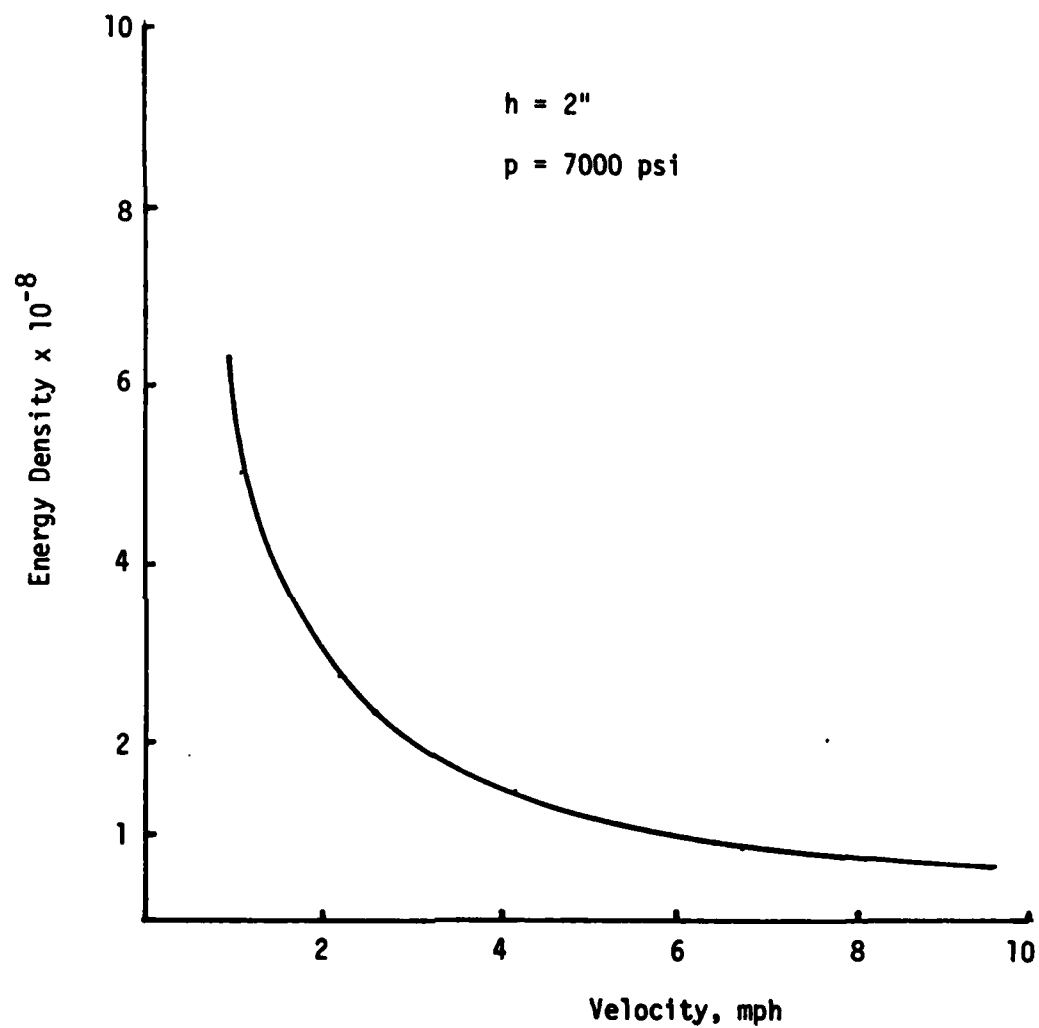
Figure B-5. Influence of Vehicle Speed on the Work Done on the Surface.

The graphs in Figure B-5 through B-7 illustrate the variation produced in the energy density with variability in the operating parameters. Typical ranges for these operating parameters have been indicated for comparison purposes only.

It can be clearly seen that variation in the pressure is not as critical to the effectiveness of the removal procedure as the variation in vehicle speed or the height of the spray bar. This indicates where care must be used in the high pressure removal process.

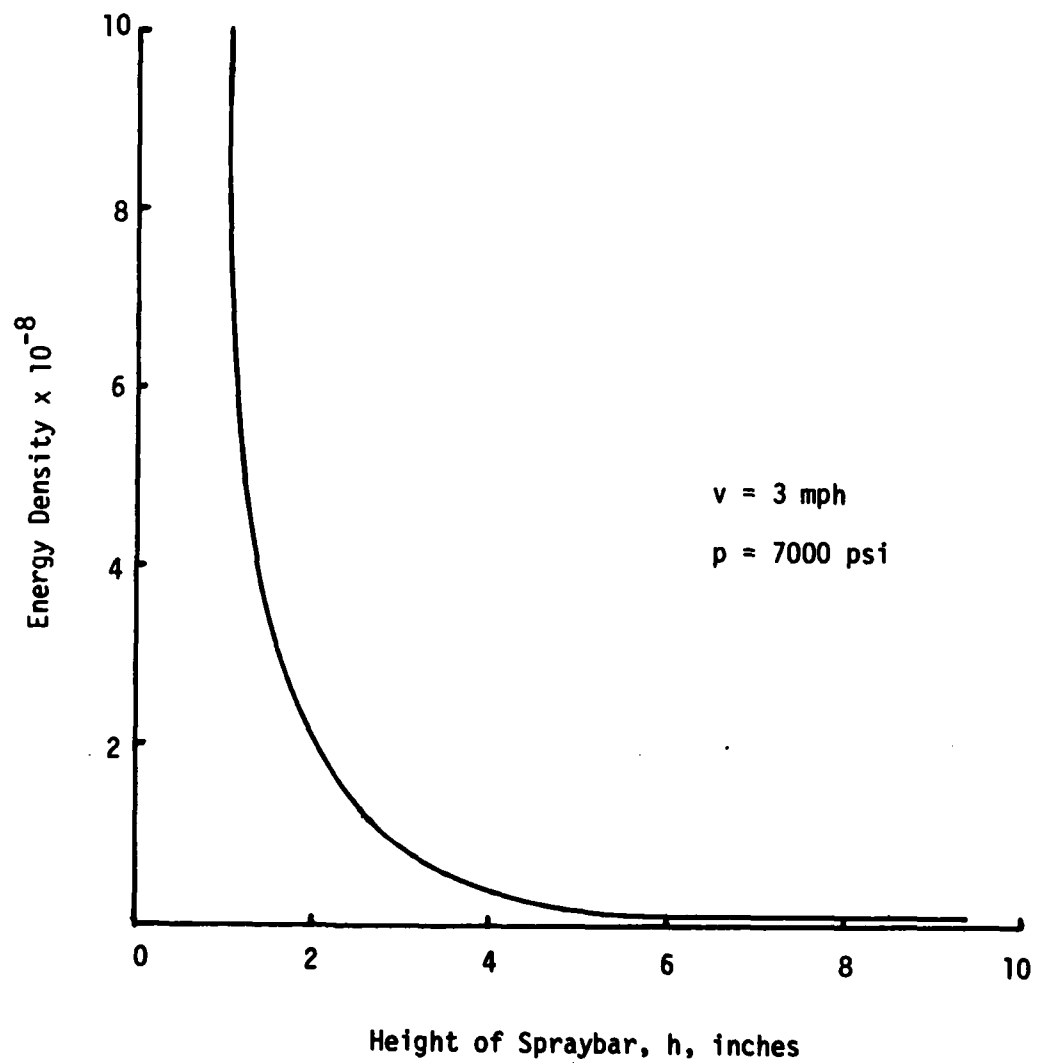
Figure B-6. Influence of Spraybar Height on the Work Done on the Surface.

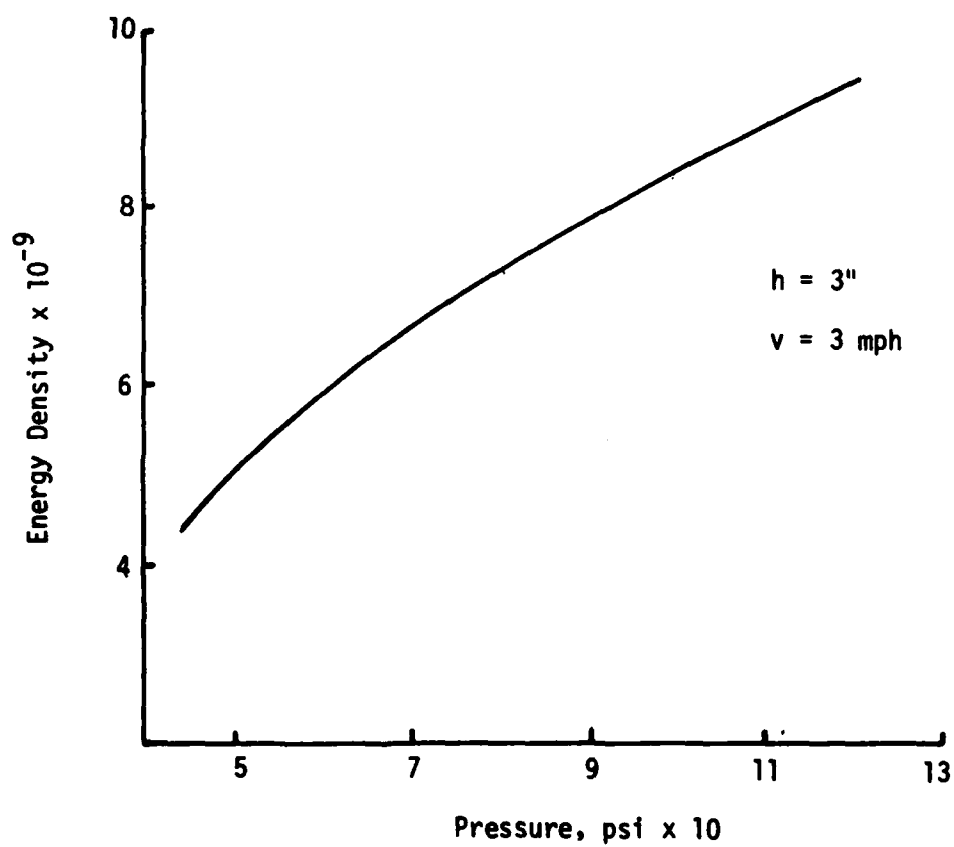
Figure B-7. Influence of Pressure on the Work Done on the Surface.
